**NOSSA-TR-2004-001** 22 January 2004  
Ordnance Environmental Support Office  
Technical Report

# **Field Demonstration of In Situ Perchlorate Bioremediation at Building 1419**

By Randall J. Cramer and Carey Yates  
Indian Head Division  
Naval Surface Warfare Center

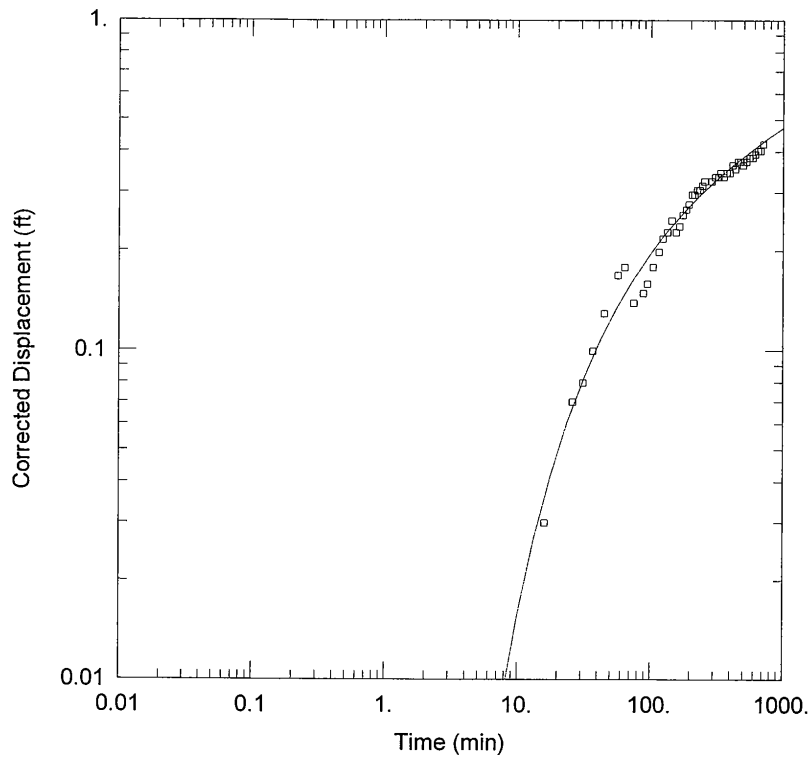
#### WELL TEST ANALYSIS

Data Set: Q:\APPS\AQTW\PMW5.AQT

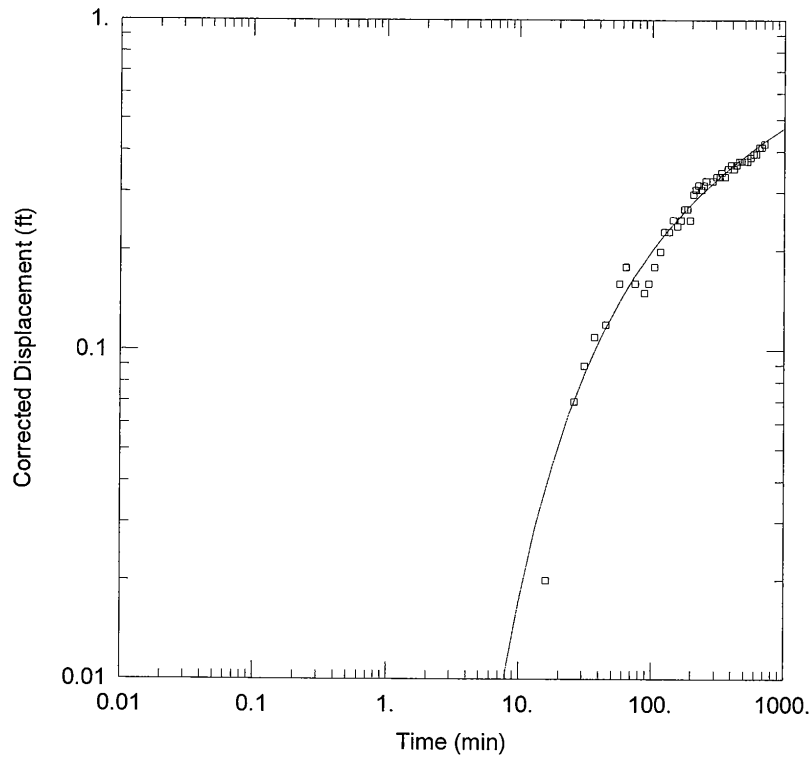
#### WELL TEST ANALYSIS

Data Set: Q:\APPS\AQTWPMW6.AQT
